Downtown Pathway Project – Site Assessment

August 19, 2021

ENGINEERING
RESOURCES, INC.

ALLEYWAY ASSESSMENTS

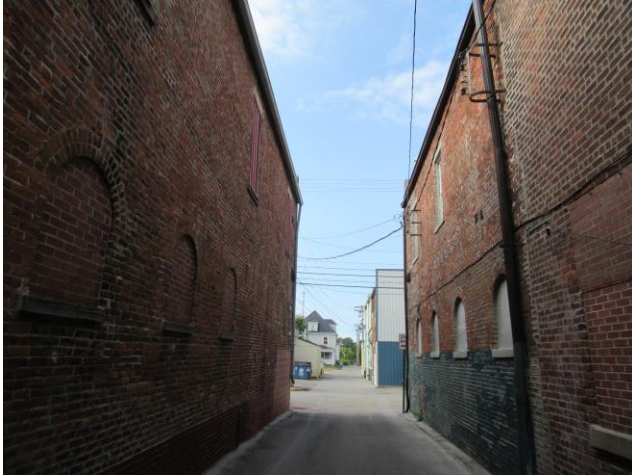
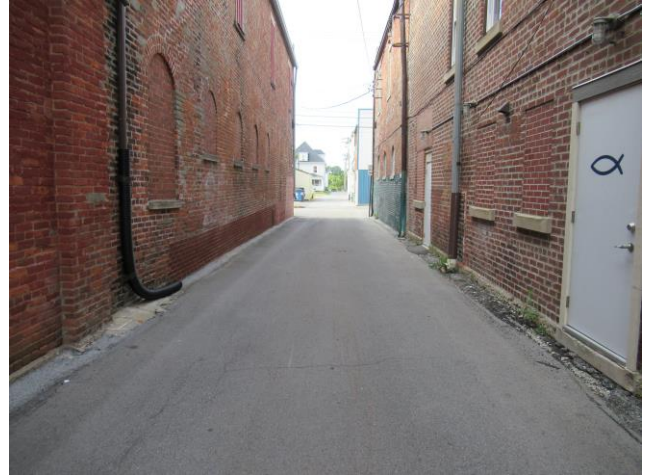
ALLEY "1" (NORTH 100 BLOCK OF W. MARKET ST.):

Relatively flat with no glaring slope issues for ADA compliance.

Downspouts daylight onto pavement, potential for ice.

Door thresholds, one door with a step, the other has pavement patch for a flush condition.

Lighting exists above door height along building owned by Foundations.

Asphalt pavement in decent condition, no major cracking or heaving.

Gutter lines along building are showing signs of cracking, spalling, and have collected loose debris and pavement.

Concrete patching has been done, likely because of pavement erosion from downspouts.

No storm inlets located within alley.

Crowned alley with a break line in the center, draining into gutters towards Market St. and Perry St.

Downspouts daylight onto pavement, directly into gutter line.

Air conditioning units mounted onto buildings around 2nd floor. Clearances?

Wires with significant sag along east building face, just above door height. Also wires along 2nd floor, crossing alley diagonally from SW corner to NE corner, crossing the alley at the north entrance and connecting to utility pole on Perry St.

Various types and colors of bricks even within the same building facades. Some have been painted and is fading in some places.

Some areas show significant wear and could benefit from repairs or tuckpointing.

1st floor windows have all been bricked in. 2nd floor windows on west building have been covered with metal panel.

Downspouts have varying sizes and materials.

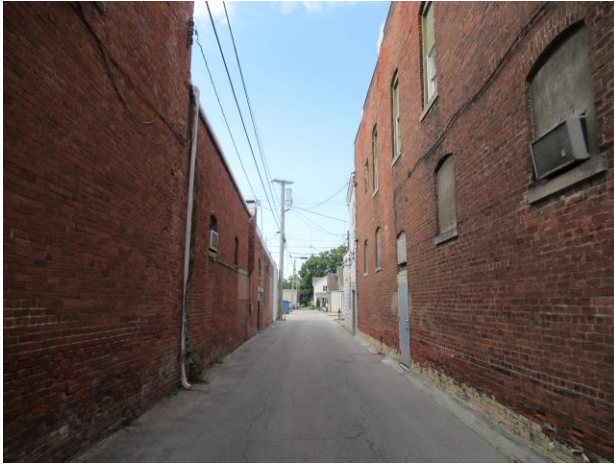
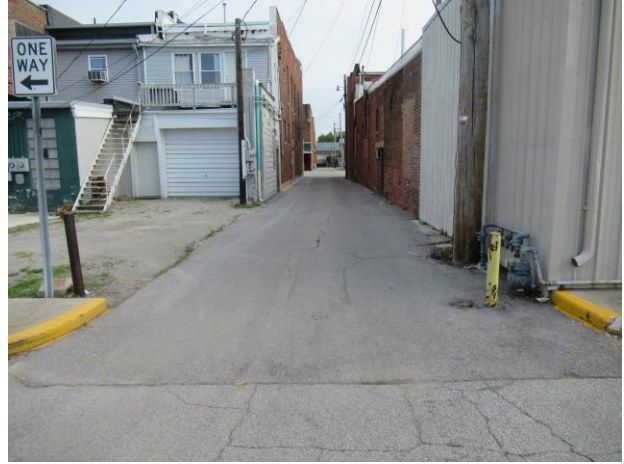
ALLEY "2" (NORTH 200 BLOCK OF W. MARKET ST.):

Relatively flat with no glaring slope issues for ADA compliance.

North sidewalk crossing has full curb, no ramps

Downspouts daylight onto pavement, potential for ice.

Door thresholds, one door with a rolled curb, the other two have flush conditions.

Single light exists on southernmost utility pole.

Asphalt pavement in decent condition, some minor cracking.

Gutter line along west building has collected loose debris, gutter line along east building has a curb to channel drainage and has broken off in some areas.

No storm inlets located within alley.

Crowned alley with a break line in the center, draining into gutters towards Market St. and Perry St.

Downspouts daylight onto pavement, daylight perpendicular to building.

Air conditioning units mounted into windows and next to door.

Wires and conduit held tight to building faces.

Two utility poles along west building face, northern pole has transformer. Lines run parallel with alley, service lines from poles to northeast building.

Utility pole with meter bank at northwest corner of the northeast building.

Gas meter located at northwest corner of northeast building, protected with steel bollard.

Various types and colors of bricks even within the same building facades. Some have been painted and is fading in some places. Painted CMU block peeling on 1st floor, and vinyl siding on 2nd floor of Northeast building, metal panel on north end of west building, showing some wear and denting.

Some areas show significant wear and could benefit from repairs or tuckpointing.

1st floor windows on east building all been covered with plywood, one window on west building covered with metal panel. 2nd floor windows on west building have been modified to have upper portion covered with plywood.

Downspouts have varying sizes and materials.

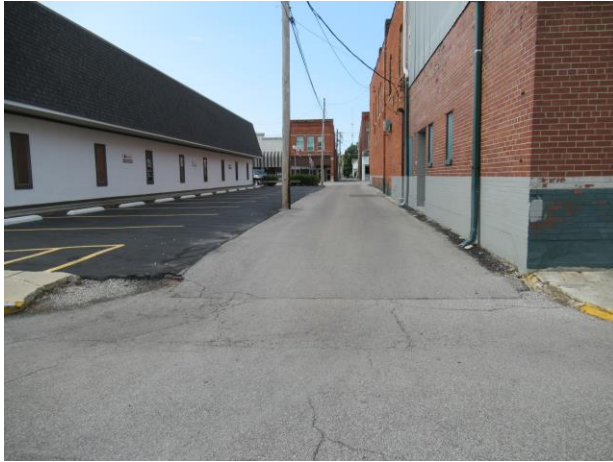
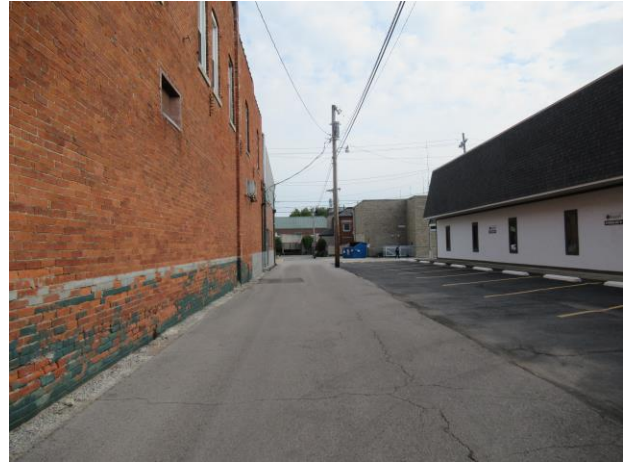
ALLEY "3" (SOUTH 200 BLOCK OF W. MARKET ST.):

Relatively flat with no glaring slope issues for ADA compliance.

South sidewalk crossing is broken

Downspouts daylight onto pavement, potential for ice.

One door threshold with 2 steps, inset into building façade.

Single light just north of door on east building face, single light on south utility pole facing parking.

Asphalt pavement in decent condition, some minor cracking and a pavement path.

Gutter line along east building is stone and has collected loose debris

No storm inlets located within alley.

Crowned alley with a break line in the center, draining into gutters towards Market St. and Walnut St., parking drains towards alley.

Downspouts daylight onto pavement, daylights perpendicular to building.

Wires and conduit held tight to building faces.

Two utility poles along west edge, southern pole has transformer. Lines run parallel with alley, service lines from poles to east building.

Some brick on east has been painted which has come off in some places. The south portion of the east building has metal panel on the 2nd floor.

Some areas show significant wear and could benefit from repairs or tuckpointing.

1st floor windows on east building all been covered with painted plywood, one old door has been infilled with metal panel.

Downspouts have similar sizes, color and materials.

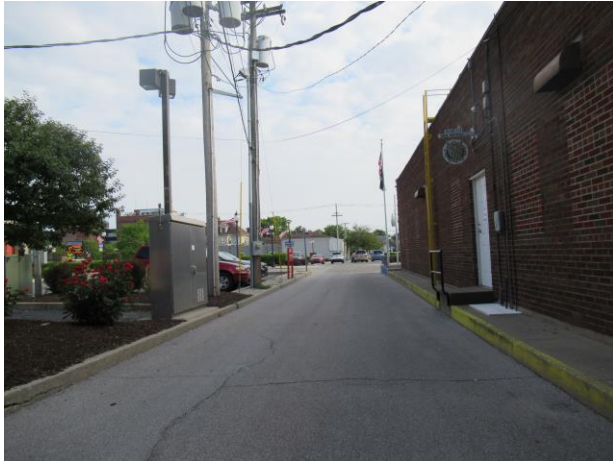
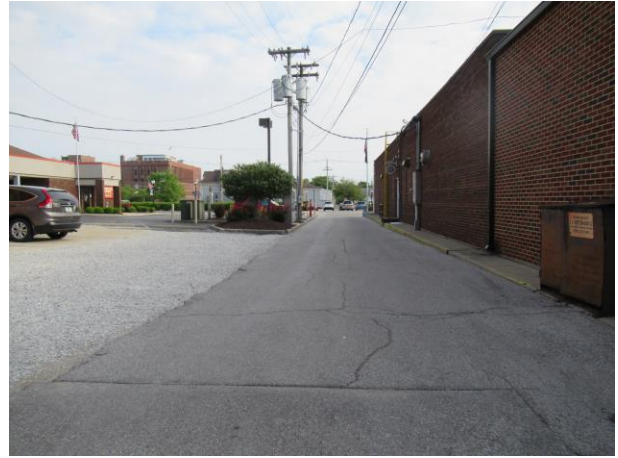
ALLEY "4" (NORTH 100 BLOCK OF W. WASHINGTON ST.):

Relatively flat roadway with no glaring slope issues for ADA compliance.

Sidewalk along west building face has various impediments and is not ADA accessible.

Downspouts daylight onto pavement, potential for ice.

Door threshold, one door with an elevated stoop and handrail, not ADA accessible.

Parking lot light in south parking lot on east side of alley.

Pedestrian crossing sign located on east side near Washington St.

Asphalt pavement has some minor cracking and some broken areas along northeast edge.

Curb on south half of east side, curb face walk on west side that goes from flush on north end to a small wall on the south end, wall has guardrail, curbing and walk seem to be in decent condition

No storm inlets located within alley.

Crowned alley that transitions to a single slope going east on north end, drains into gutters towards Walnut St. and Washington St.

Downspout daylight onto concrete walk, drainage from building under sidewalk and onto alley pavement in multiple locations, curb cuts with pvc pipe along south parking lot

Grease disposal bin located on curb face sidewalk.

Meters and conduit held tight to building faces.

Vents located along west building face above door height.

Access ladder on west building face with lockable guard.

Two utility poles with 4 transformers and ground mounded utility cabinet along south parking lot. Utility pole with single light located on west side at north end. Lines run parallel with alley, between all the pole, and service lines from poles to the west building.

Brick building façade with some brick infills for old doors and windows.

Some areas show minor wear.

Sign above door on west building face with signage lighting.

Parking lot signage located near south parking lot on east side.

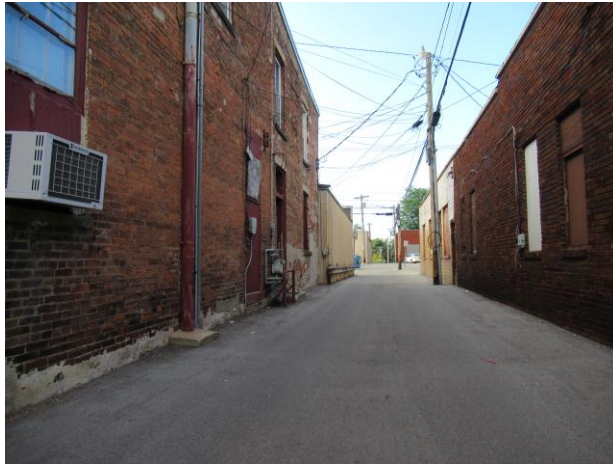
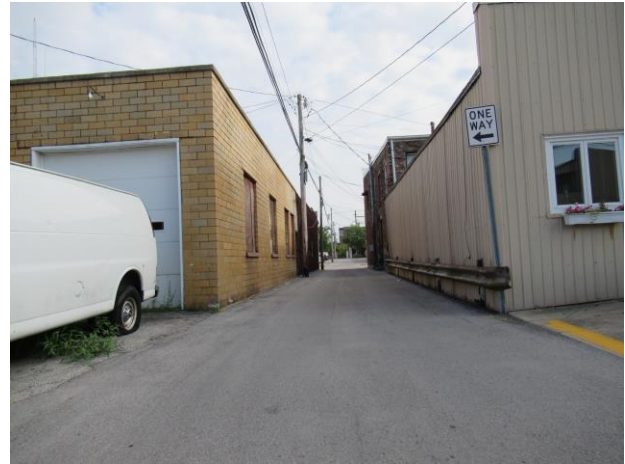
ALLEY "5" (NORTH 100 BLOCK OF E. MARKET ST.):

Relatively flat with no glaring slope issues for ADA compliance.

No downspouts.

Door thresholds, door on west with two steps last step is within alley, the east door has a flush condition.

Single light exists on northernmost utility pole.

Asphalt pavement in decent condition.

Gutter line along buildings have collected loose debris, some concrete in the gutter hasn't been overlaid.

No storm inlets located within alley but one on north end in Perry St. gutter line.

Crowned alley with a break line in the center, draining into gutters towards Market St. and Perry St. Pavement warps towards inlet in Perry St. gutter line.

Air conditioning unit mounted into 1st floor window on west building face.

Wires and conduit on building faces.

Two utility poles along east building face. Lines run parallel with alley, service lines from poles to buildings.

Vent pipe from basement to roof on west building.

Meters located at door on west building protected with bollards.

Bricks on east face seem to be in good shape, bricks on west are showing some wear. Some bricks on west building have been mortared over in attempt to repair wall. CMU was also used to repair west building façade. Northwest building is metal panel with guardrail tight to the building along the entire face. The north portion of the east building has a larger tan colored brick.

Some areas on the west building face show significant wear and could benefit from repairs or tuckpointing.

1st floor windows on east building all been covered with plywood except two near north ends, some 1st floor windows along with an old door opening on west building have been cover with plywood as well.
